**State of Louisiana  
Department of Natural Resources  
Coastal Engineering Division**

**2006/2007 Annual Inspection  
Report**

**SABINE REFUGE PROTECTION  
PROJECT (CS-18)**

March 22, 2007  
Cameron Parish

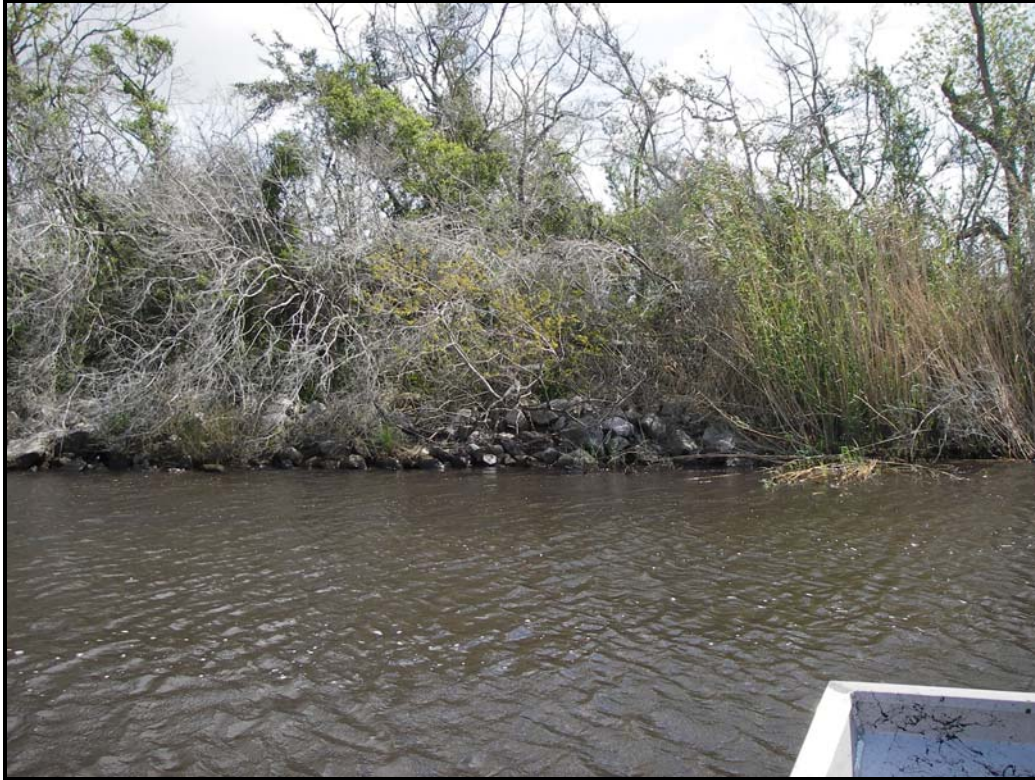
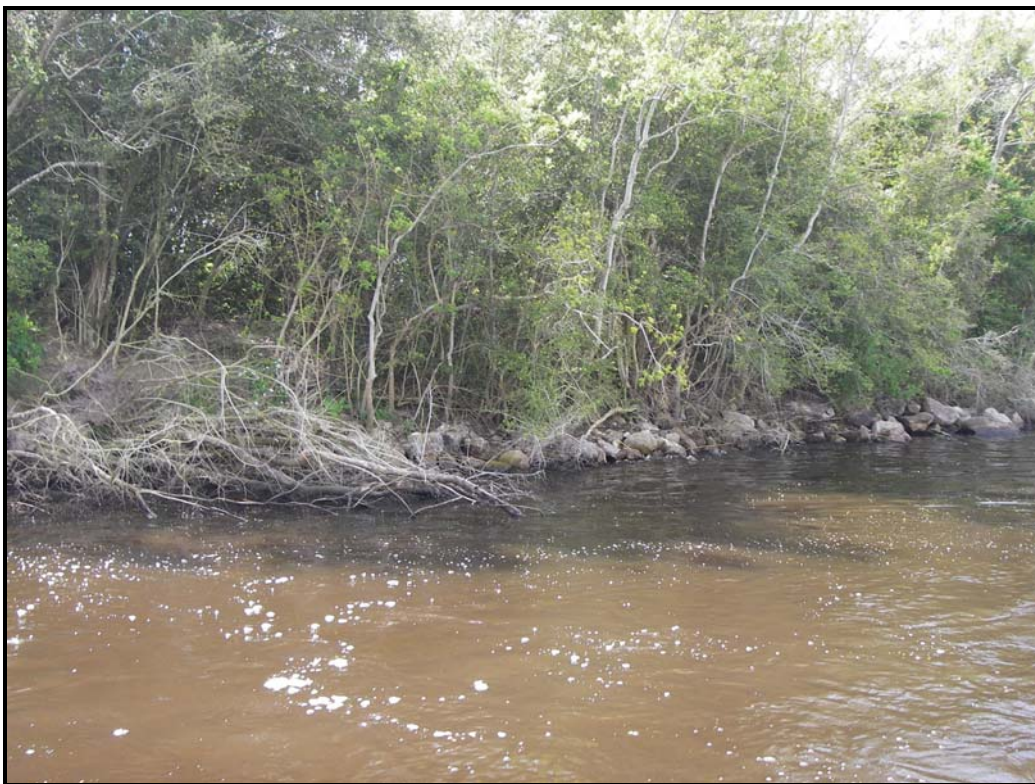
The rock breakwater along the Burton Sutton Canal was inspected along its entire reach. The water level in the Burton Sutton Canal was estimated to be +1.1 NAVD88. The dike is in excellent post construction condition. No need for any maintenance in the foreseeable future. (Photos: Appendix B, Photos 1 - 2)

Photo 1—southern tie-in on Burton Sutton Canal (March 22, 2007)

Photo 2—northern tie-in on Burton Sutton Canal (March 22, 2007)

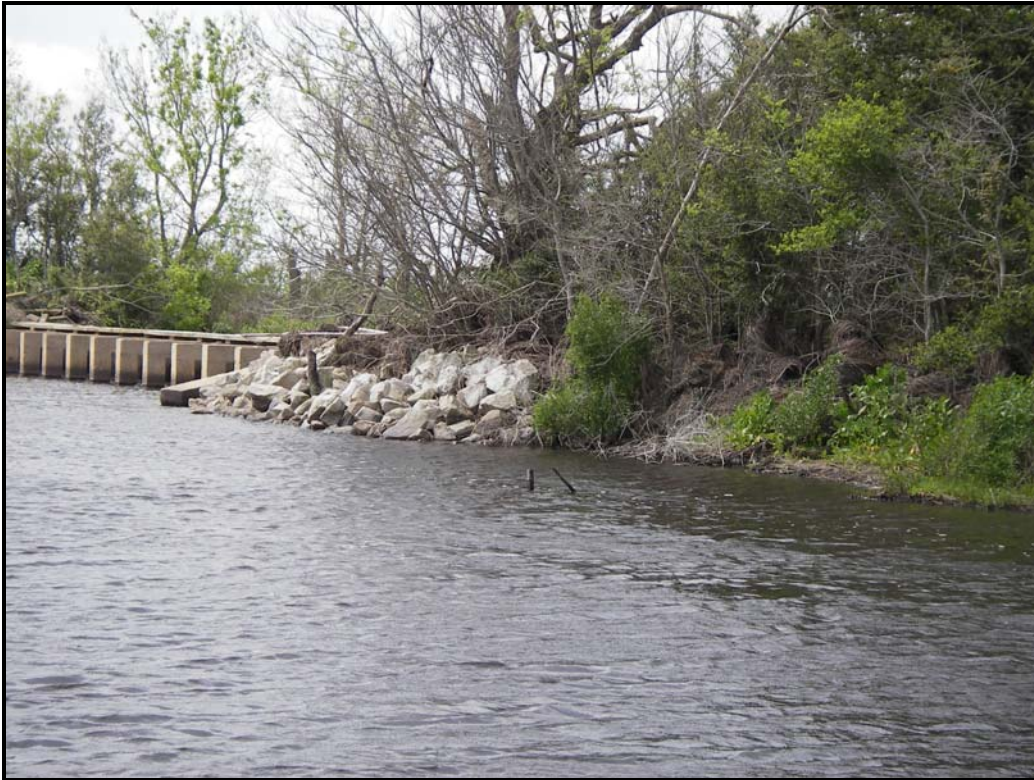
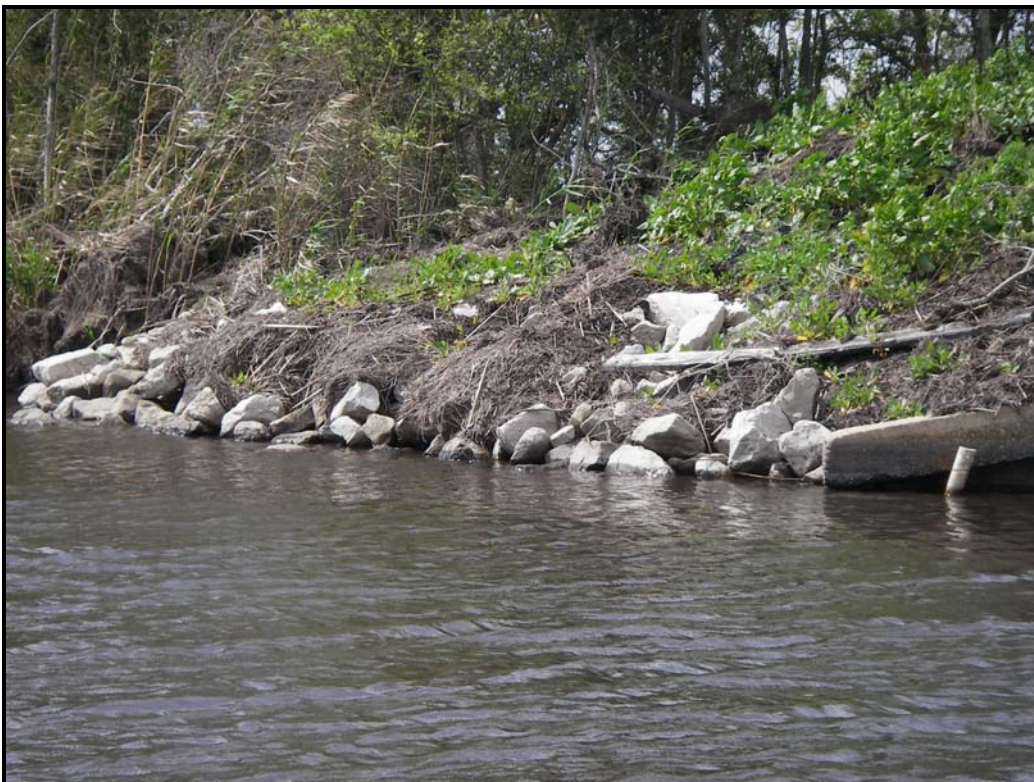
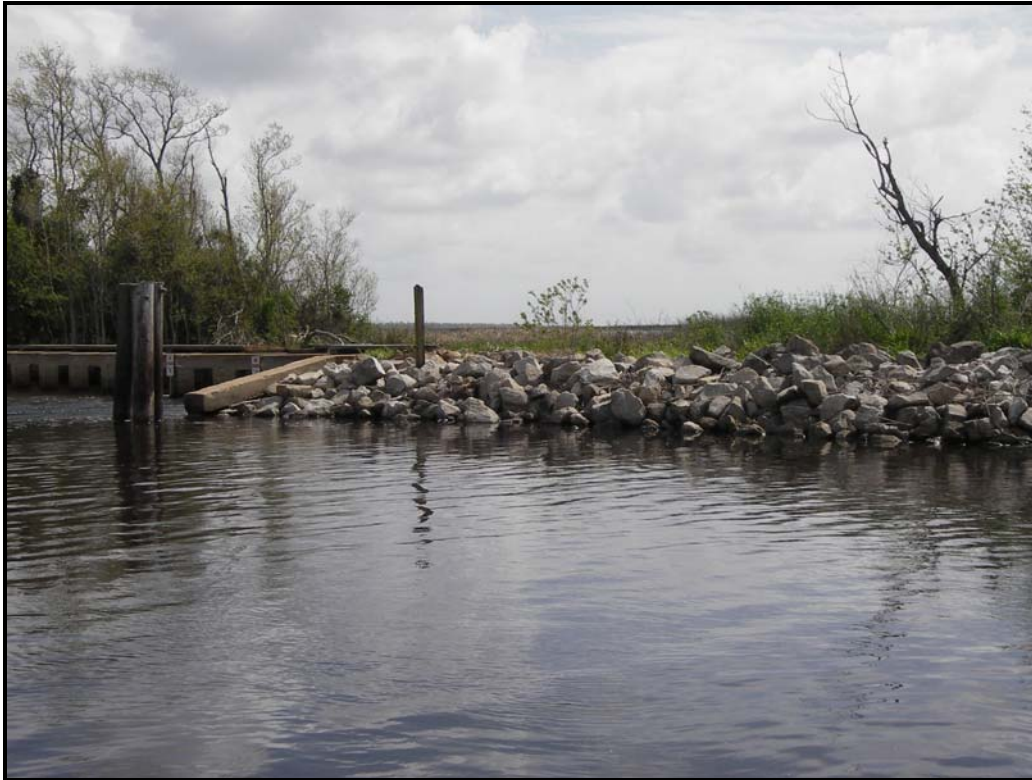
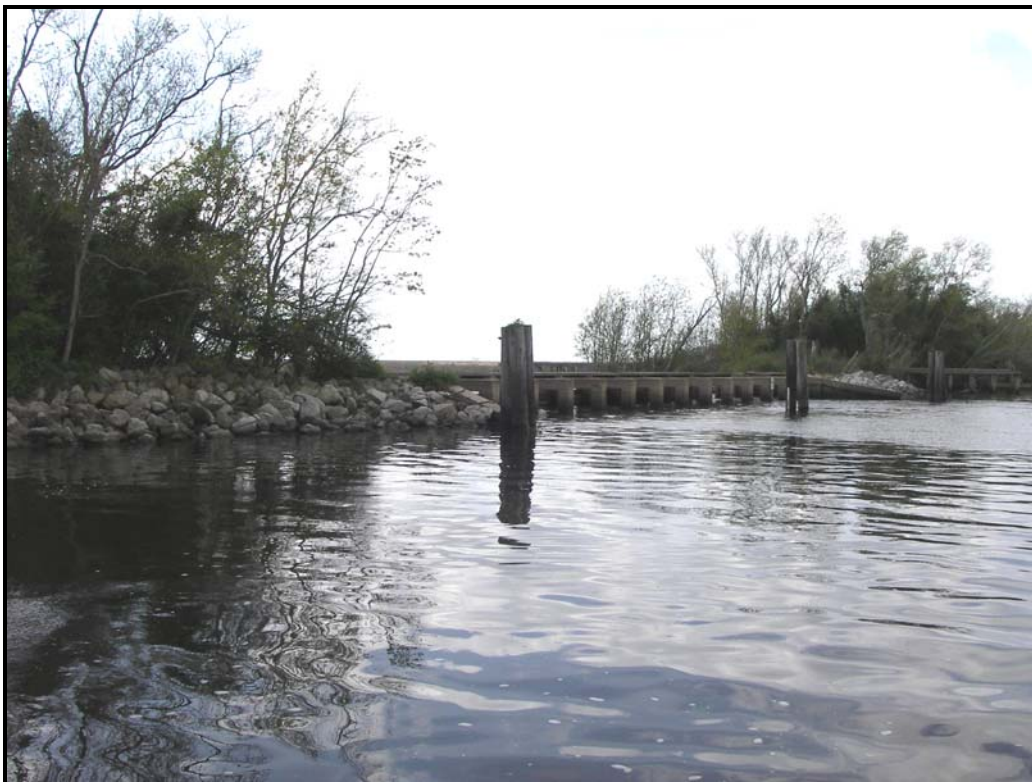
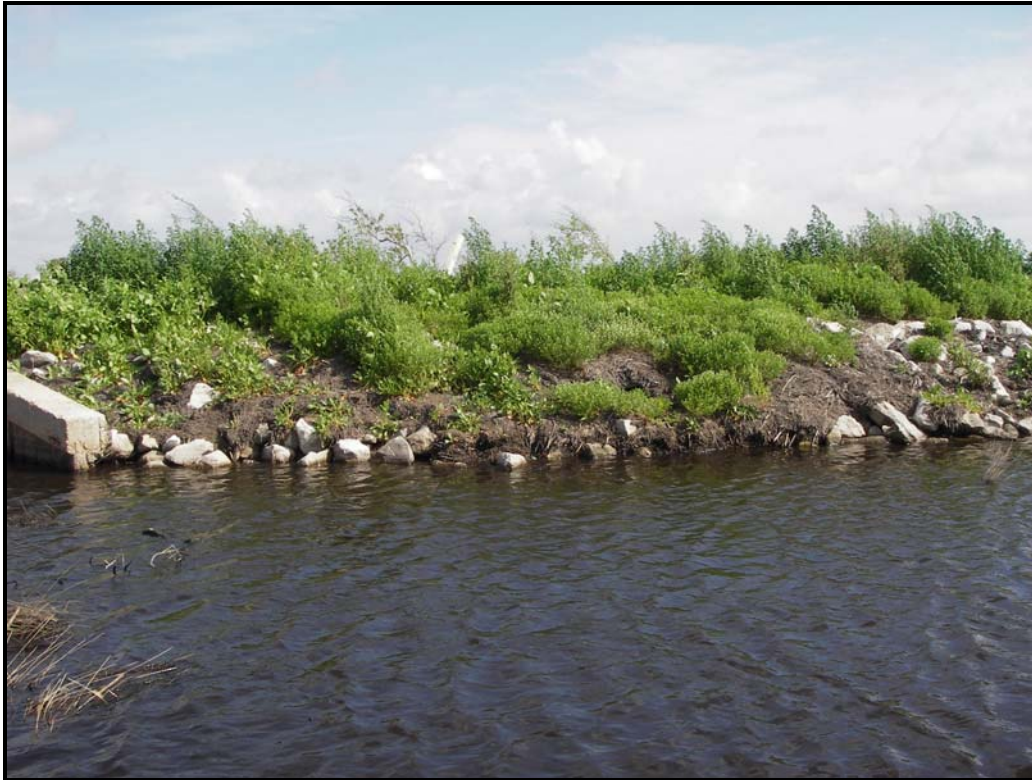
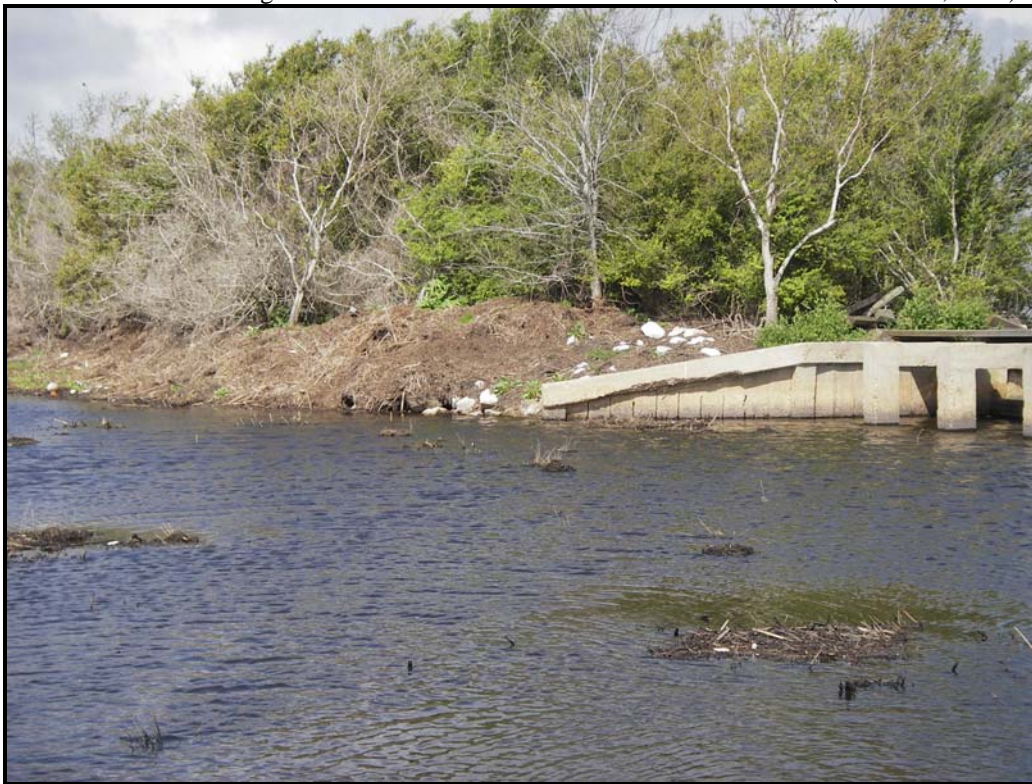
The weirs at Beach Canal Structure No. 2, Northline Canal Structure No. 3, and Stark's Central Canal Structure No. 4 were inspected for rock reinforcement at each wingwall. No maintenance required at any of the structures at this time. (Photos: Appendix B, Photos 3-8).

Photo 3—northern wingwall rock on Beach Canal Structure No. 2 (March 22, 2007)

Photo 4—southern wingwall rock on Beach Canal Structure No. 2 (March 22, 2007)

Photo 5 – southwest wingwall rock on Northline Canal Structure No. 3 (March 22, 2007)

Photo 6 – northeast wingwall rock on Northline Canal Structure No. 3 (March 22, 2007)

Photo 7 – eastern wingwall rock on Stark's Central Canal Structure No. 4 (March 22, 2007)

Photo 8 – western wingwall rock on Stark's Central Canal Structure No. 4 (March 22, 2007)

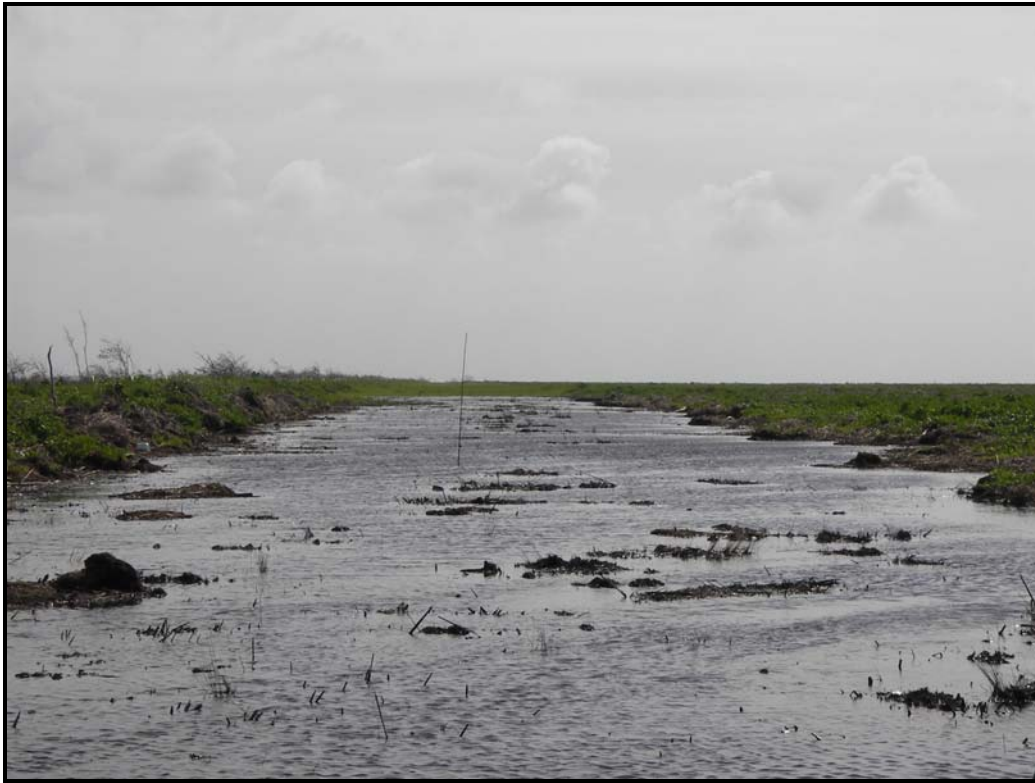
Portions of the Stark's Central Canal were clogged with wrack and debris from Hurricane RITA. USFWS plans to leave this material in place to help control water flow in the refuge. (Photos: Appendix B, Photo 9).

Photo 9 – Central Canal, view looking east, showing canal clogged with wrack and debris from Hurricane RITA which will remain in place. (March 22, 2007)
